**The flood resilience of light frame timber structures**

# The flood resilience of light frame timber structures

for the degree of Doctor of Philosophy

Department of Architecture and Civil Engineering

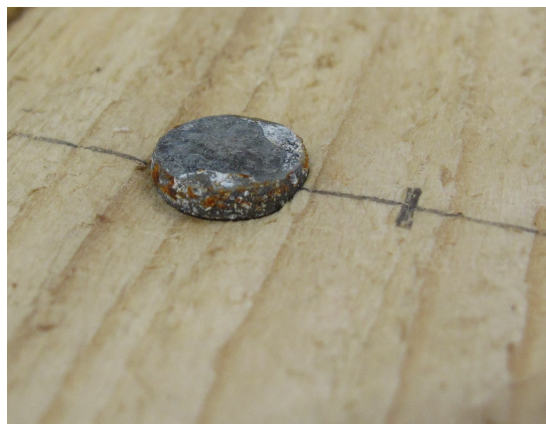
Figure 2-11: Galvanised nail showing the effects of submersion in water. The nail is beginning to show signs of corrosion after seven days of submersion. This is despite the fact galvanised nails were used. Image courtesy of [82].

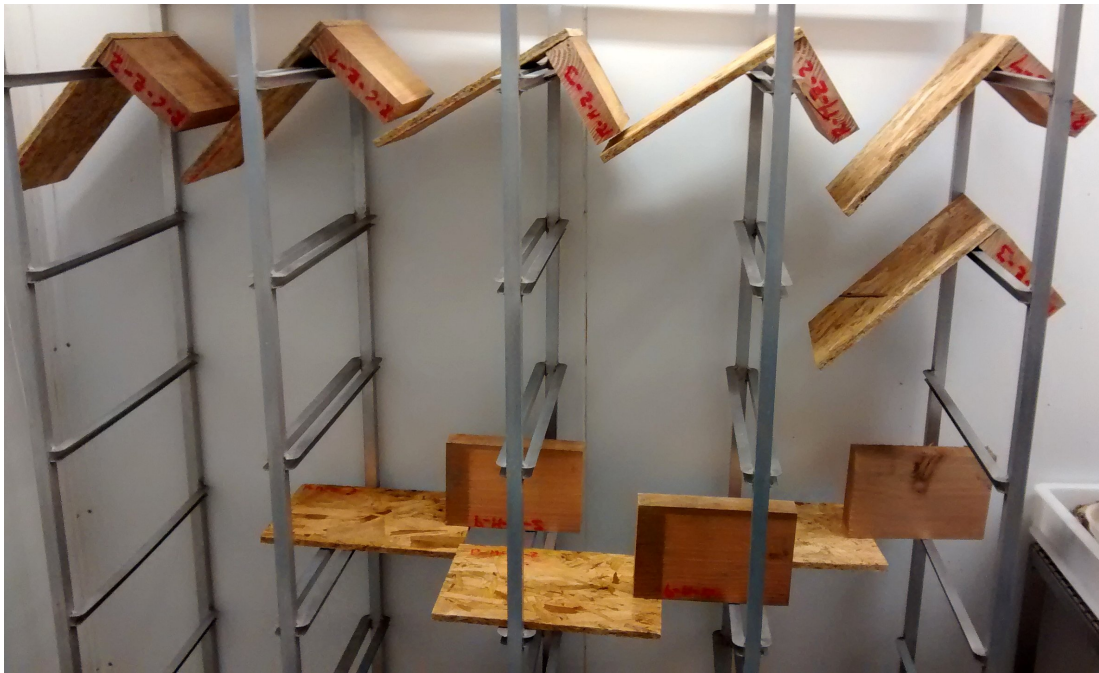
Figure 4-2: Specimens drying in the environmental chamber. Each specimen is arranged to provide maximum airflow around it, ensuring equal exposure to the chamber conditions and even drying of each specimen.

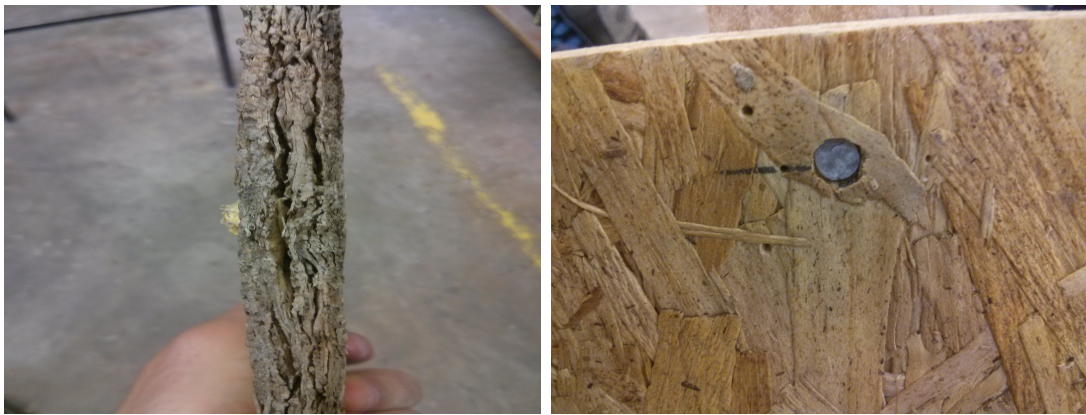
(a) Example of swelling in the OSB sheathing. (b) Example of the nail head punching through OSB due to thickness swelling of OSB.

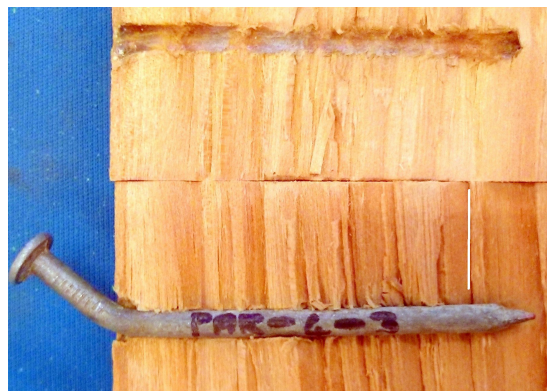
Figure 4-10: Specimen opened after testing to show degree of nail bend. There is no axial displacement and only limited bearing into the timber at the open end of the nail hole. The nail bend is approximately  $40^\circ$ . This specimen was tested parallel to grain. Grain direction indicated by white line.

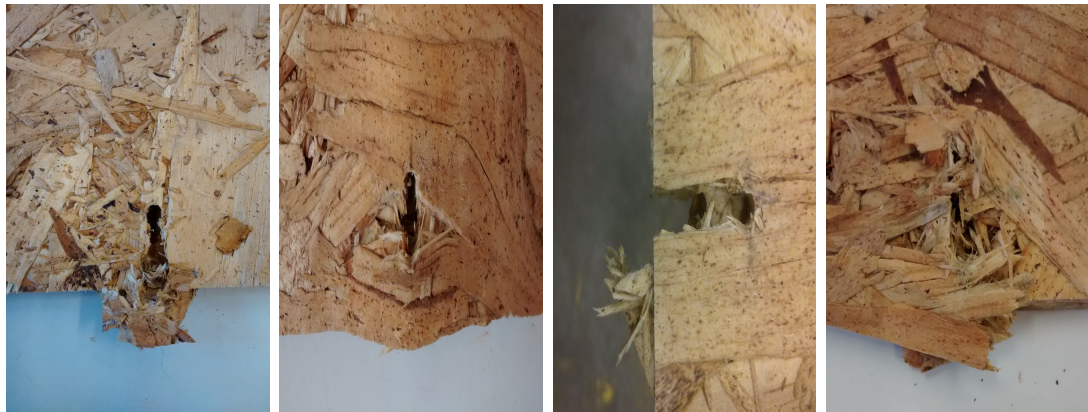
(a) Nail ripped out of OSB base. (b) Nail pull through back of the OSB. (c) Clean nail rip out of the OSB base. (d) Nail rip out of OSB base showing increased displaced material.

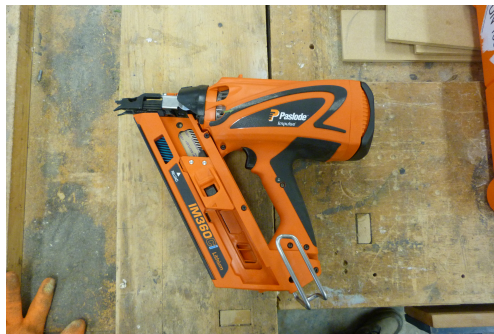
Figure 5-1: Gas powered framing nailer.

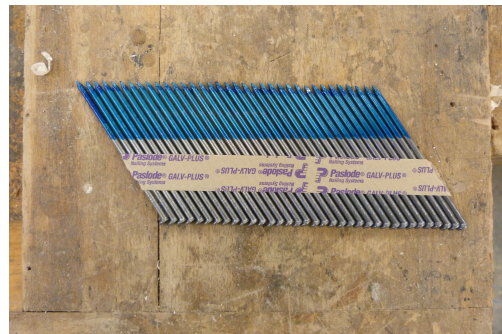
Figure 5-2: 90 mm galvanised steel nails.

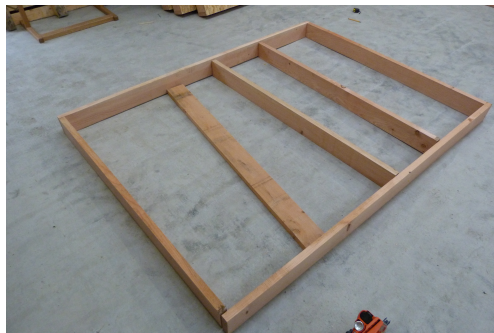
Figure 5-3: Timber frame during assembly.

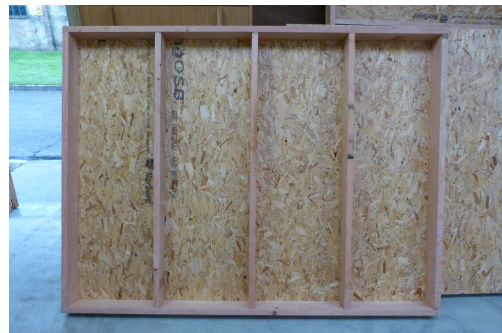
Figure 5-4: Fully assembled wall.

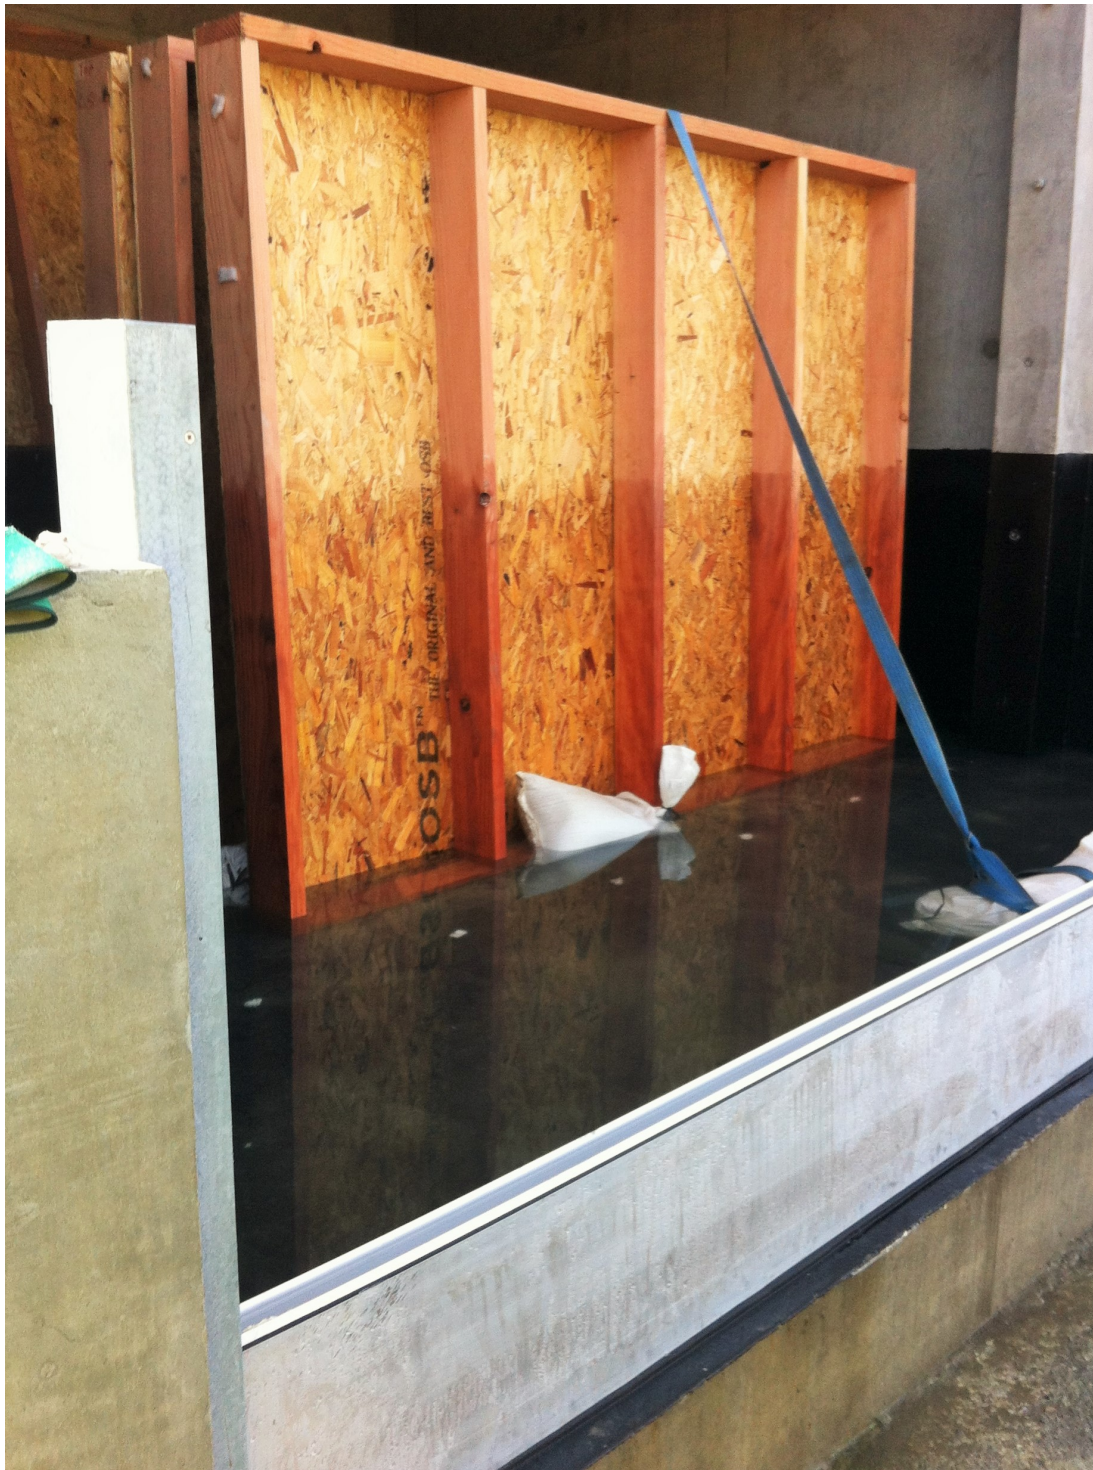
Figure 5-5: Wetting of walls at the University of Bath's HIVE facility. The flood barrier has been disassembled to allow specimen removal. The high water line can clearly be seen on the specimens in the tank.

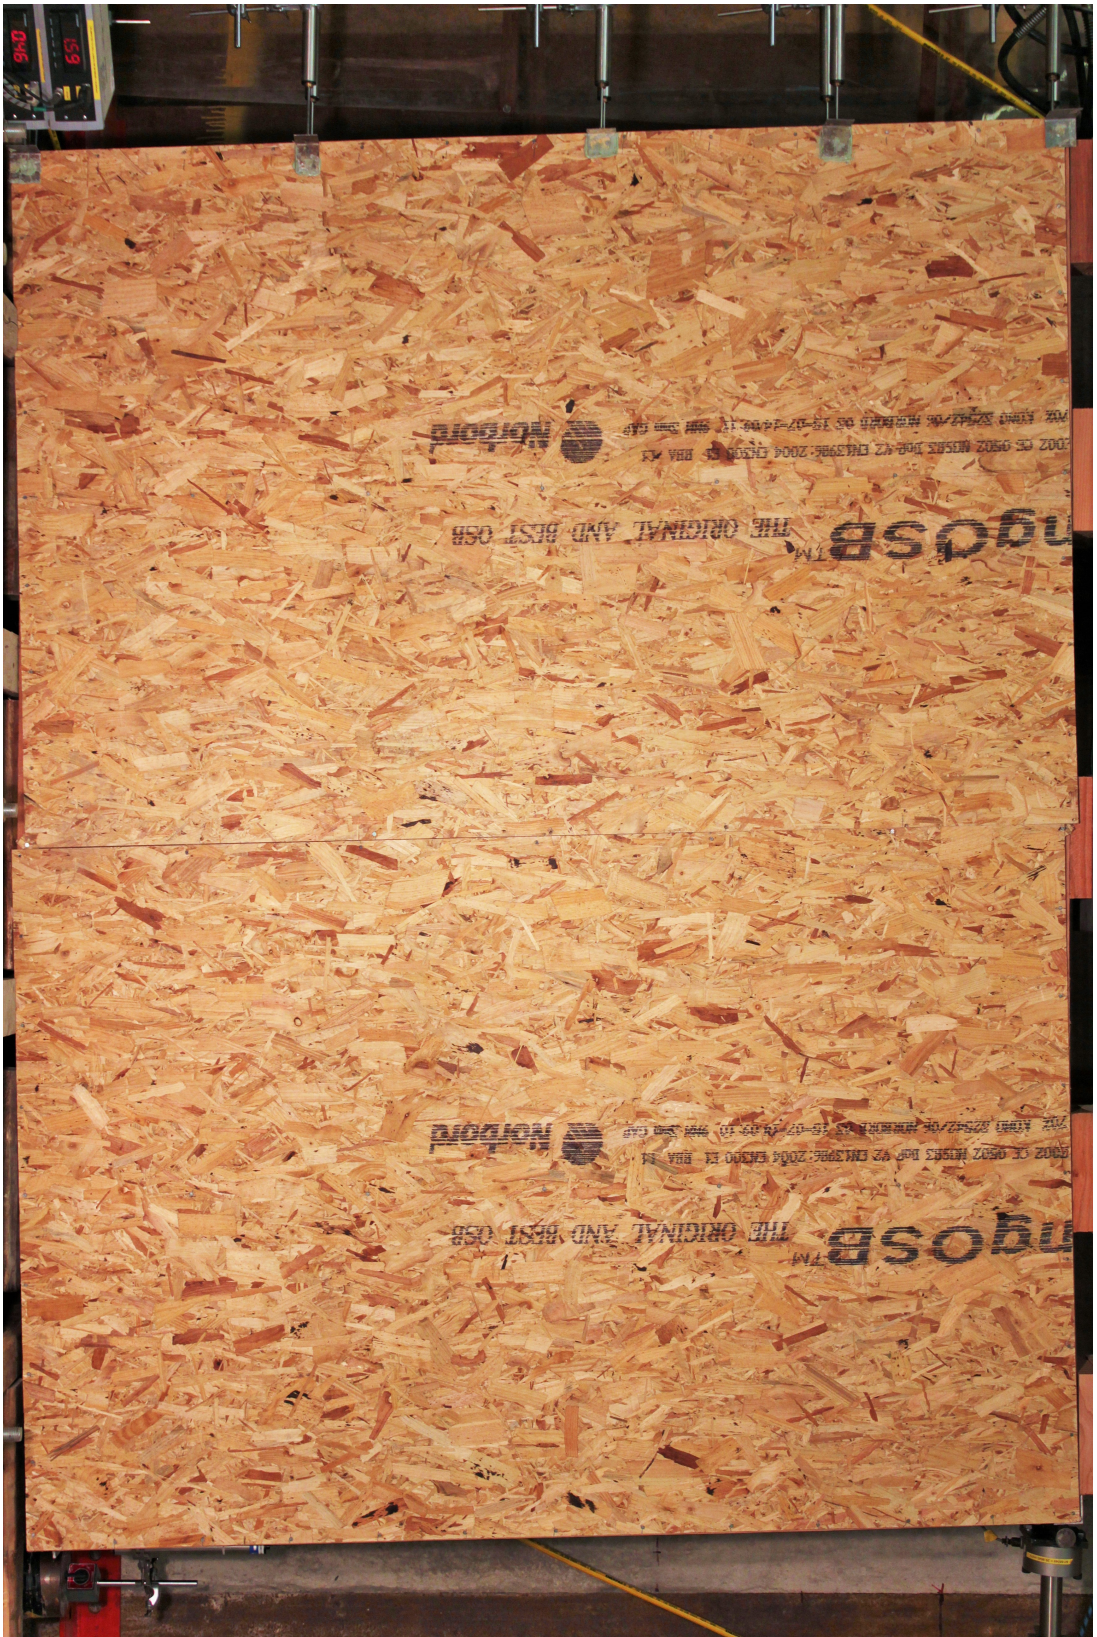
Figure 5-10: Control wall illustrating typical failure of shear wall following load testing. The wall has displaced horizontally and the OSB sheathing has visibly rotated.

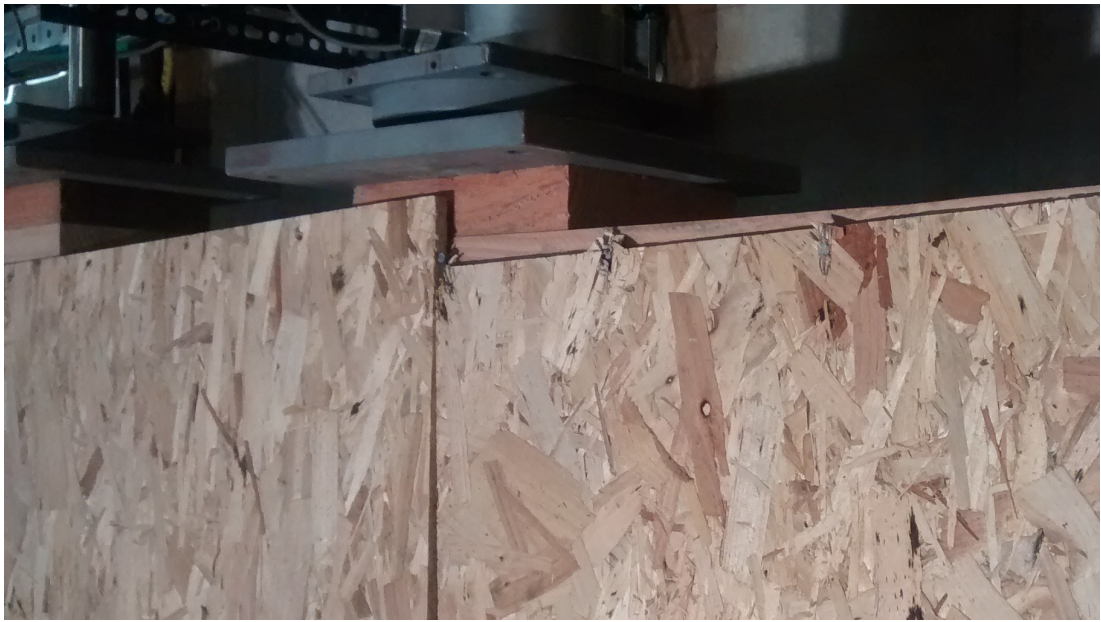
Figure 5-11: Progressive OSB failure of sheathing. Initial nail rip out occurs in the extreme corner of sheathing where relative displacement between timber and OSB is maximum. Failure then progresses to the nail at the location of next greatest relative displacement as overall wall displacement increases.

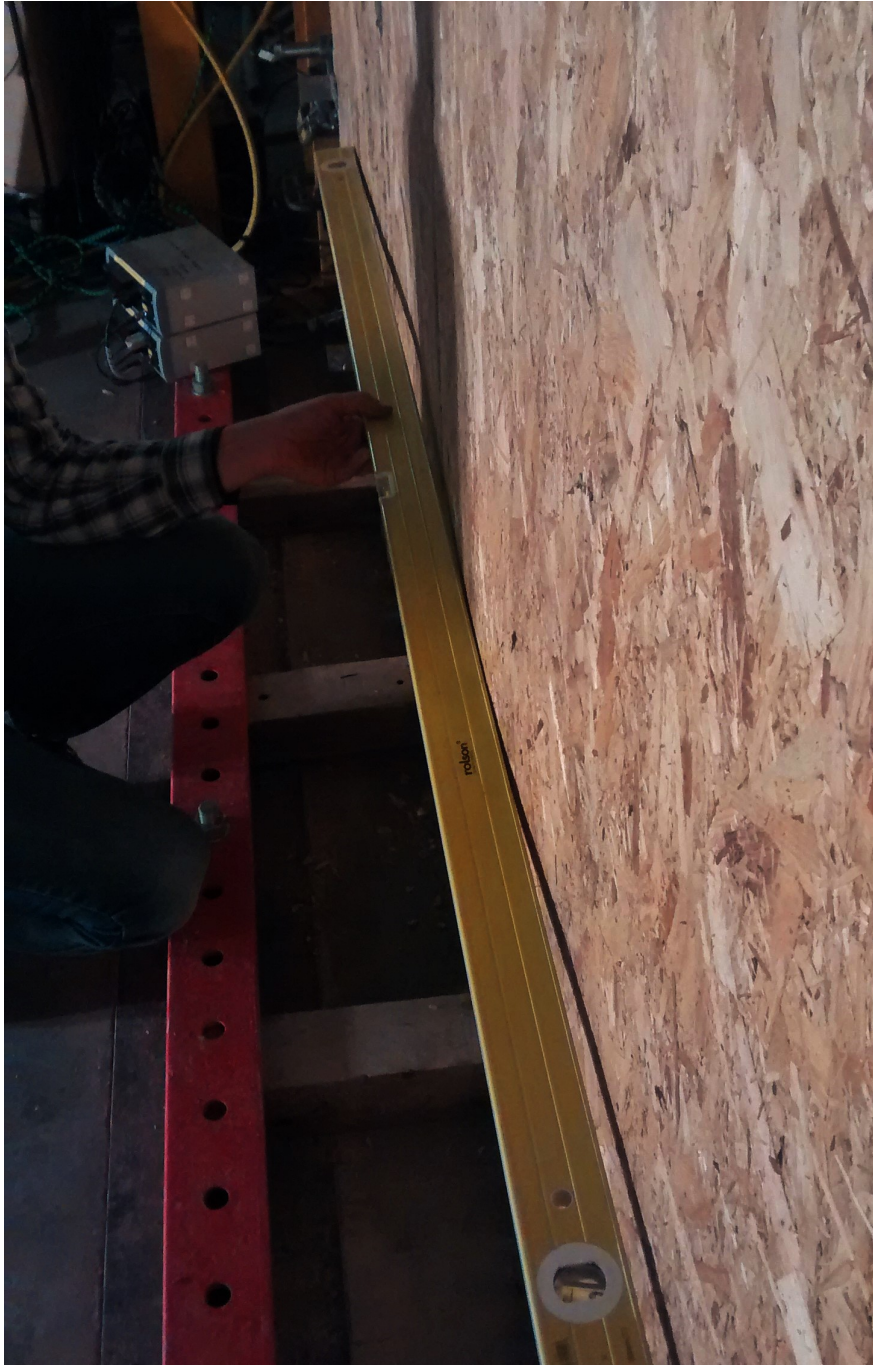
Figure 5-12: Horizontal curvature of the sheathing due to flooding. The OSB has a permanent out of plane curvature between studs. Note the gap between the edge of the level and the sheathing board due to the curvature.

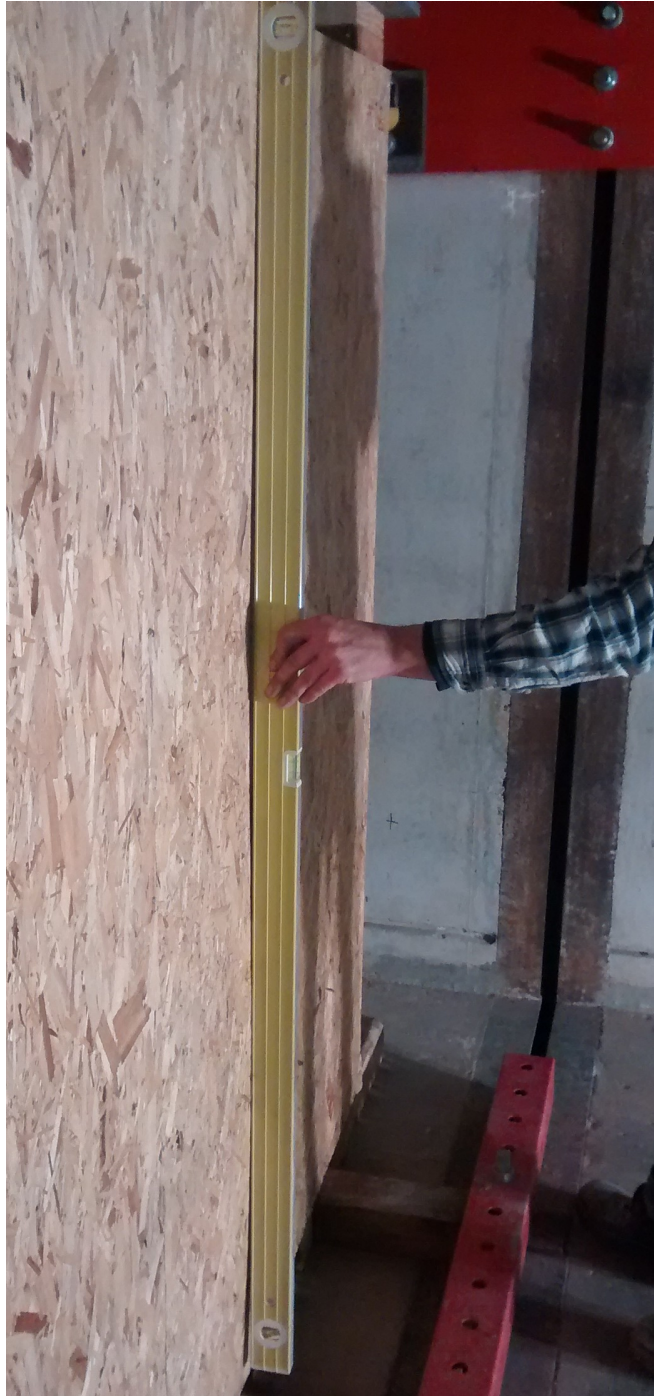
Figure 5-13: Vertical curvature of sheathing due to flooding. The OSB has a permanent out of plane curvature between studs. The vertical curvature is less pronounced than the horizontal curvature in Figure 5-12. Note that the board distortion occurs only in the lower half of the wall where the OSB was wetted.

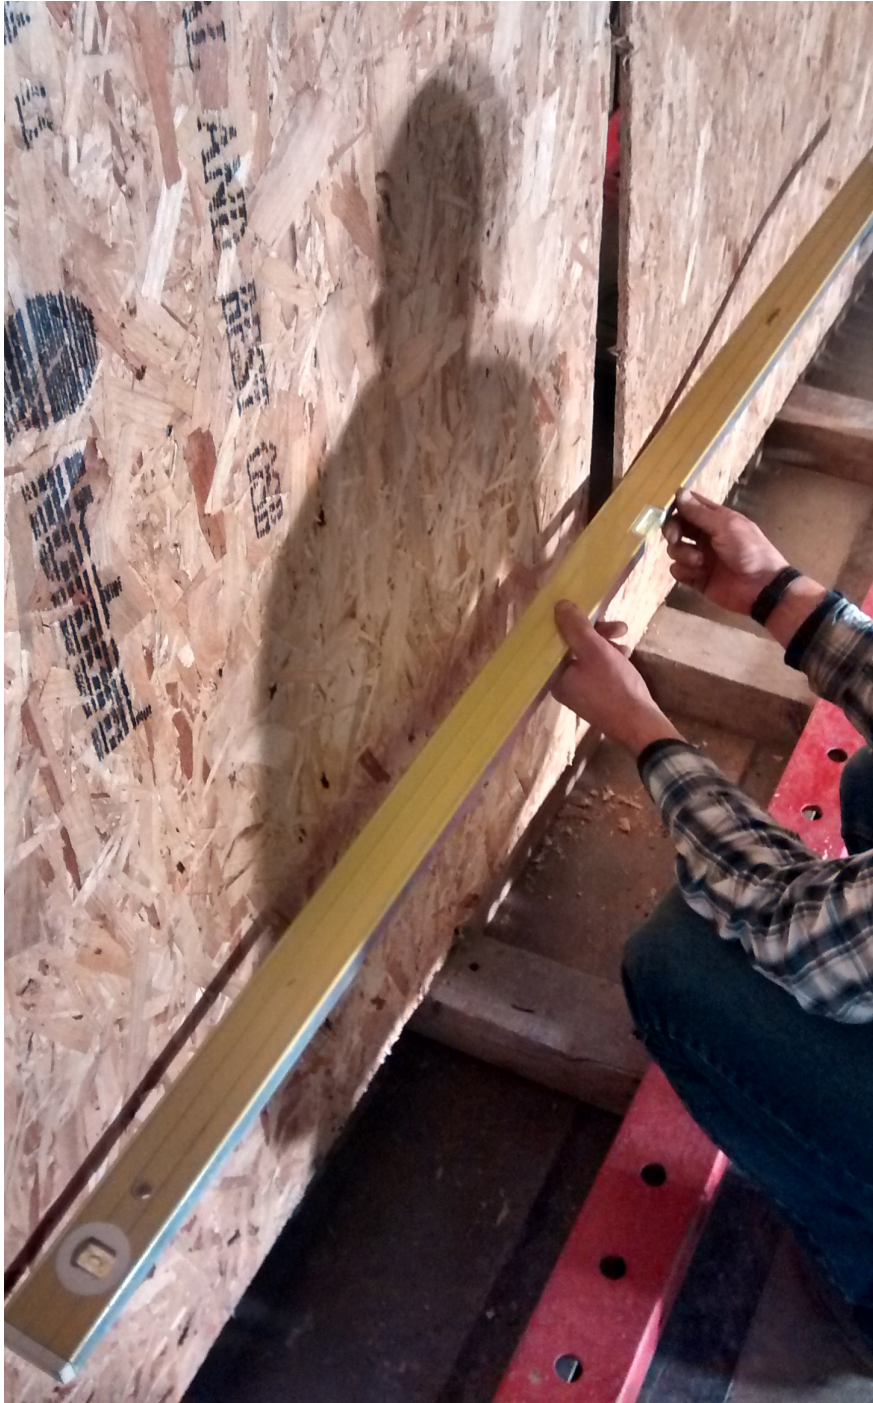
Figure 5-14: An example of the out of plane failure due to the bending of the sheathing. Here the curvature in the OSB has caused the sheathing to buckle away from the wall along the edge of a sheet.

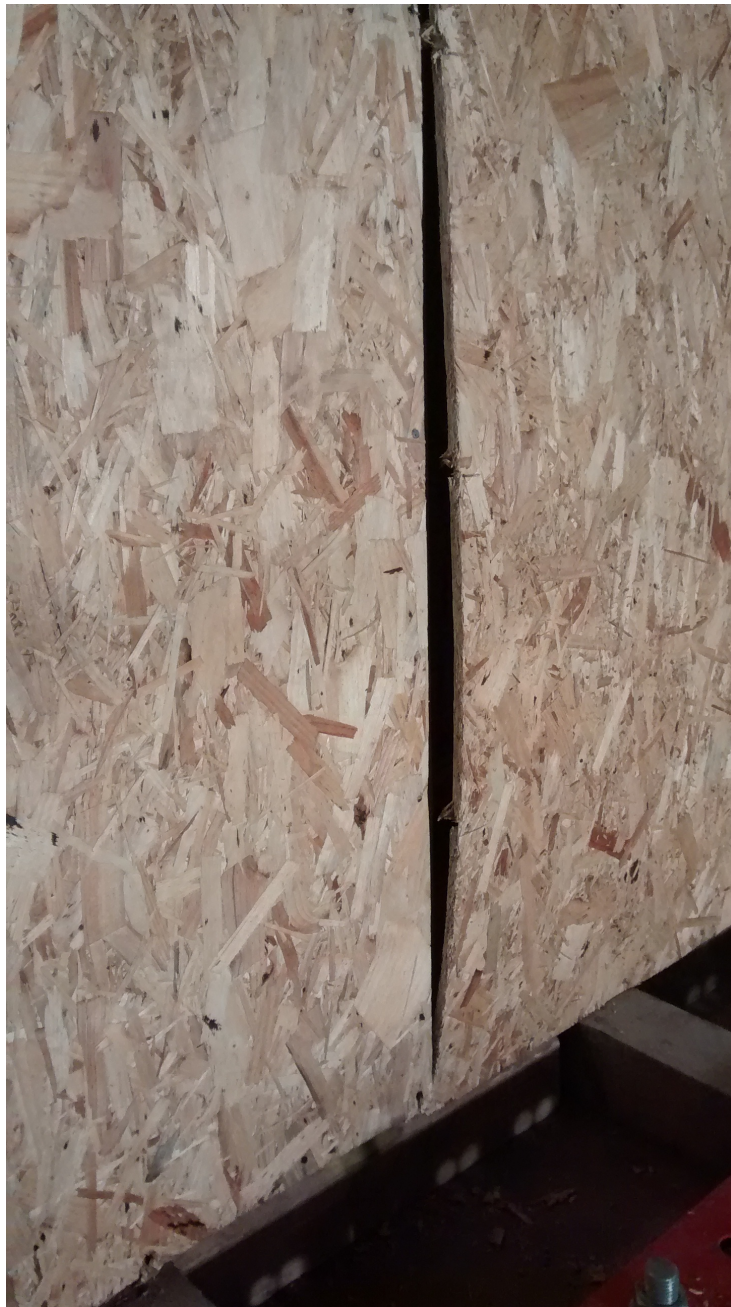
Figure 5-15: Another example of the out of plane buckling failure due to the curvature of the sheathing. The sheathing buckles off the wall, with the nails pulling through the back of the OSB, rather than ripping out.

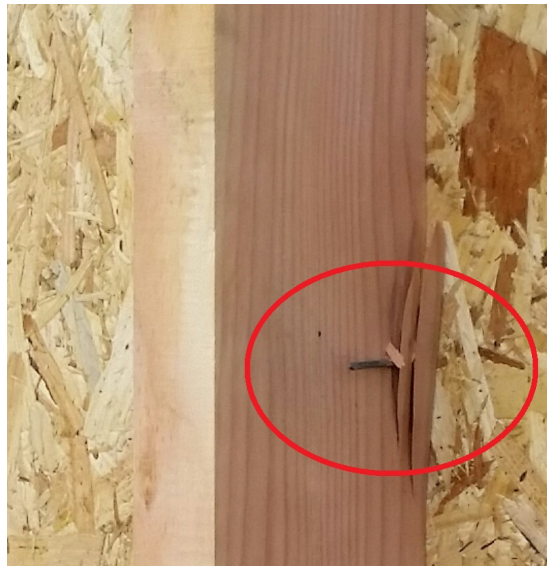
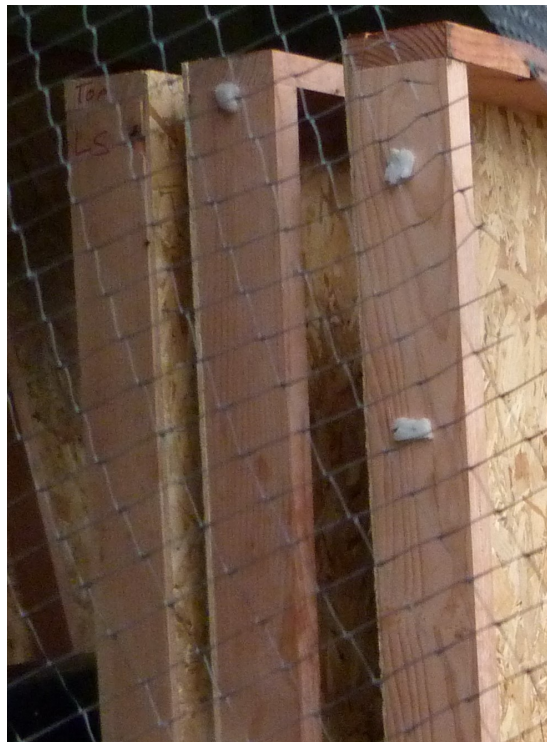
(a) Example of a misfired nail. The nail gun was not perfectly aligned with the frame and the point of the nail has exited the timber frame member to the side, reducing the connection strength.

(b) Examples of misfired nails along side of panels. Points of nails are covered by protective foam to prevent them catching or injuring anyone during transport. These misfires are a result of changes in timber density causing the nail to bend as it passes through the member.
